RECORDS OF FRIABLE AND NONFRIABLE ACBM  
(FORM B)

THREE-YEAR REINSPECTION

SCHOOL YCCA Charter School					CDS CODE 57-10579-0137422
ADDRESS (NUMBER) (STREET) (CITY) (ZIP) 1280 Santa Anita Court, Suite 190 Woodland 95776					SCHOOL PHONE NUMBER (530) 668-3777

AHERA 3 Year Reinspection  
 Performed by: Blake Howes  
 June 7, 2018  
 Project #18-4798

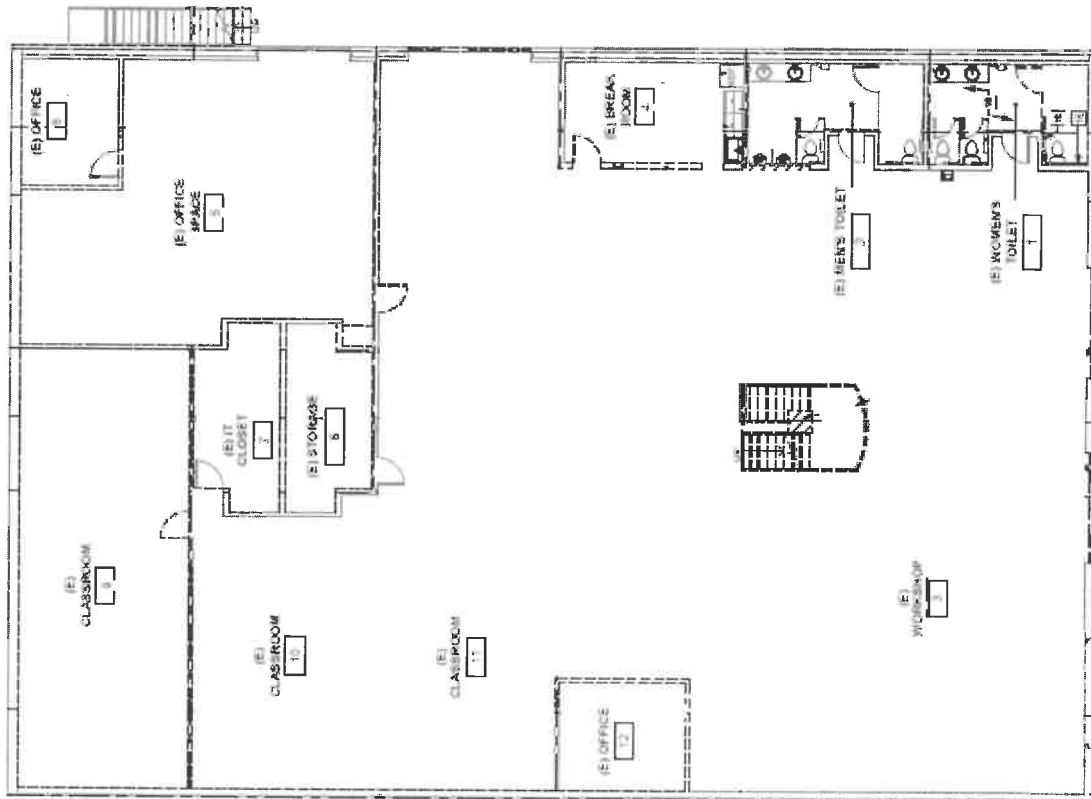
First Floor

Material Class	Material	Homo. Mat. #	% Asb.	F <sup>2</sup> (S)/L.F.(L)	Location	Condition: Code & Comments	Friable Yes/No
M	Carpet Adhesive	1	NONE DETECTED	6,200 S	Throughout except restrooms, break room, & IT room	(13) Samples ECG-18-4799-01A, 01B, 01C collected 6-7-18	n/a
M	12" White Ceramic Floor Tile	2	NONE DETECTED	400 S	Restrooms	(13) Sample ECG-18-4799-02A collected 6-7-18	n/a
M	12" White Speckled Vinyl Floor Tile	3	NONE DETECTED	200 S	IT room	(13) Sample ECG-18-4799-03A collected 6-7-18	n/a
M	12" Blue/Gray Mottled Vinyl Floor Tile	4	NONE DETECTED	200 S	Break room	(13) Sample ECG-18-4799-04A collected 6-7-18	n/a
M	4" Gray Base Cove	5	NONE DETECTED	100 S	Throughout except restrooms	(13) Samples ECG-18-4799-07A, 07B collected 6-7-18	n/a
M	Drywall & Joint Compound	6	NONE DETECTED	6,000 S	Throughout	(13) Samples ECG-18-4799-08A, 08B, 08C collected 6-7-18	n/a
S	Drywall Texture	7	NONE DETECTED	6,000 S	Throughout	(13) Samples ECG-18-4799-09A, 09B, 09C collected 6-7-18	n/a

M	2'x4' Ceiling Panels	8	NONE DETECTED	8,000 S	Throughout	(13) Sample ECG-18-4799-10A collected 6-7-18	n/a

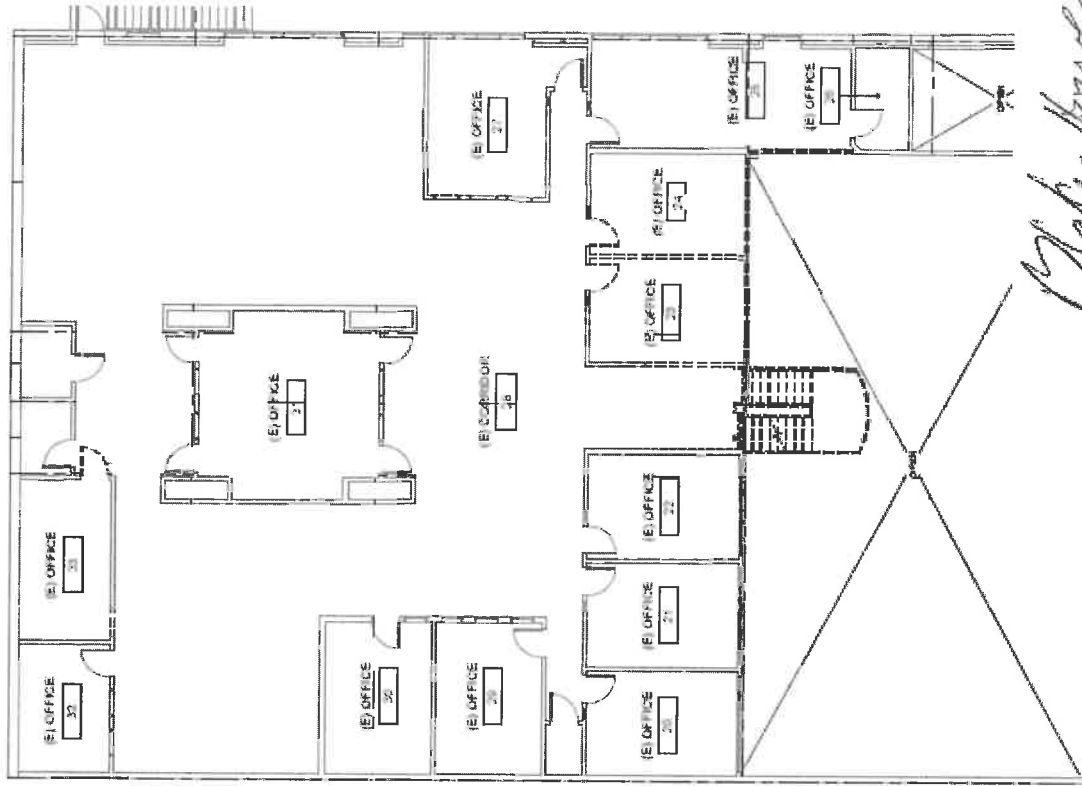
Second Floor

Material Class	Material	Homo. Mat. #	% Asb.	F <sup>2</sup> /L.F.	Location	Condition: Code & Comments	Friable Yes/No
M	Carpet Adhesive	1	NONE DETECTED	6,000 S	Throughout	(13) Samples ECG-18-4799-01D, 01E collected 6-7-18	n/a
M	4" Gray Base Cove	5	NONE DETECTED	200 S	Throughout	(13) Samples ECG-18-4799-07C, 07D collected 6-7-18	n/a
M	Drywall & Joint Compound	6	NONE DETECTED	5,000 S	Throughout	(13) Samples ECG-18-4799-08D, 08E collected 6-7-18	n/a
S	Drywall Texture	7	NONE DETECTED	5,000 S	Throughout	(13) Samples ECG-18-4799-09D, 09E, 09F, 09G collected 6-7-18	n/a
M	2'x4' Ceiling Panels	8	NONE DETECTED	6,000 S	Throughout	(13) Sample ECG-18-4799-10B collected 6-7-18	n/a
